ANNUAL EXPERIMENTAL EVALUATION REPORT

Thin-Whitetopping Bonded Composite

Location: Kalispell, Montana – Flathead County

Project No.: STPP 1-2 (93)121, East Idaho St.

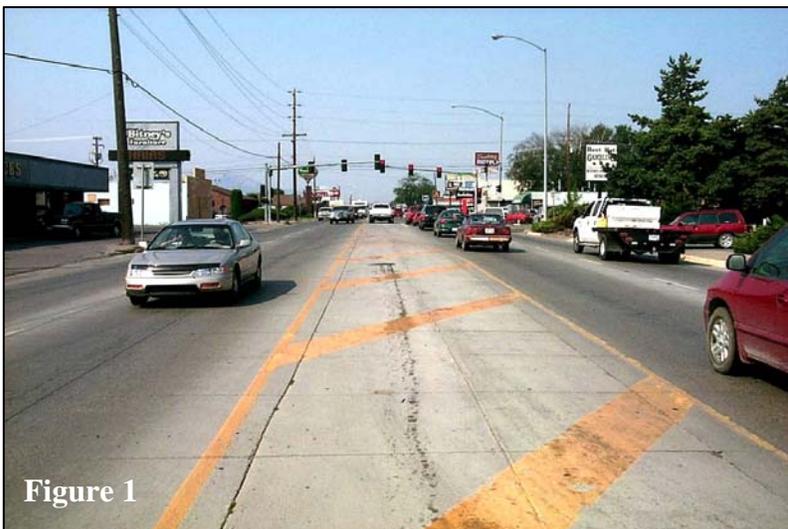
Figure 1 is an overview, looking west at the whitetopping section.

The overall appearance of the whitetopping is good. Fifteen cracked panels were documented in the 2004 report. No additional cracking was observed during this evaluation. All cracks are hairline in nature with no vertical displacement or debonding of the composite panels. At

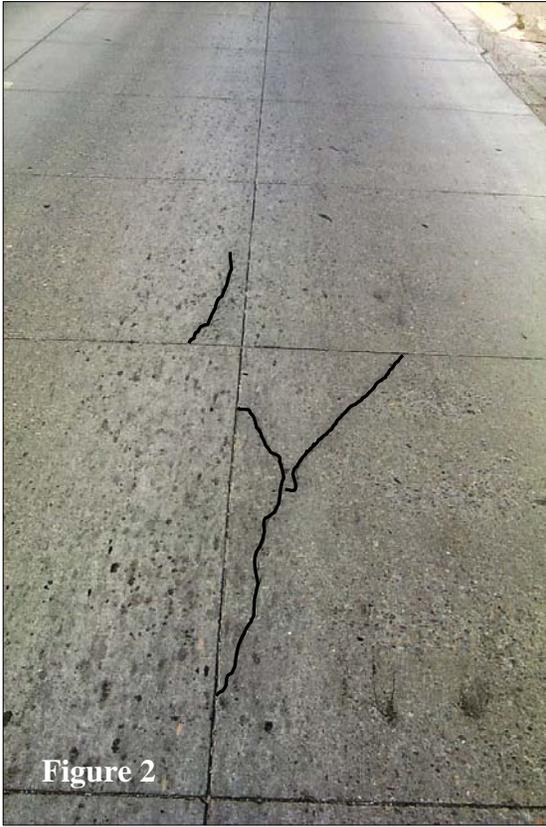
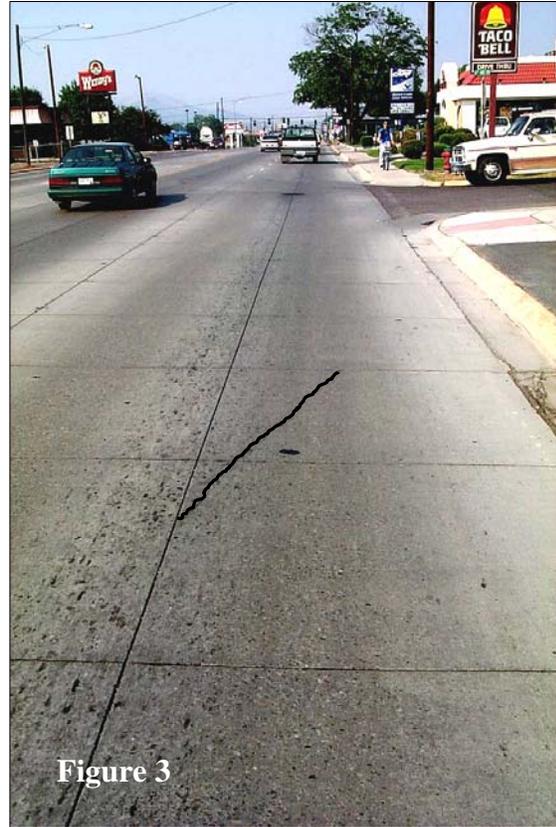
Figures 2 & 3 are examples of the in-lane, hairline cracks. A black line has been superimposed over the images to better see the lay of the crack. It has been estimated that this project contains over 4200 sawed panels with only an approximate fifteen panels exhibiting minor cracking since construction.

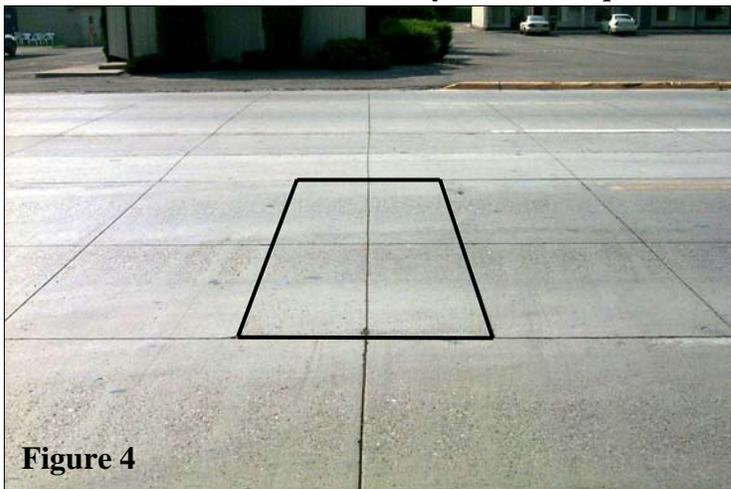
Figure 4 shows the performance of the doweled PCCP patch placed during construction due to un-consolidated concrete by lack of adequate vibration (documented in the 2001 fall construction report). The black outline is the area of repair.

Visual observation of traffic moving over this section display no faulting or movement of the slab. At this time, no visual surface distress was noticed. This repair is approximately located in the center section of the westbound lanes 2 meters past the intersection of 6th Avenue EN and East Idaho St.

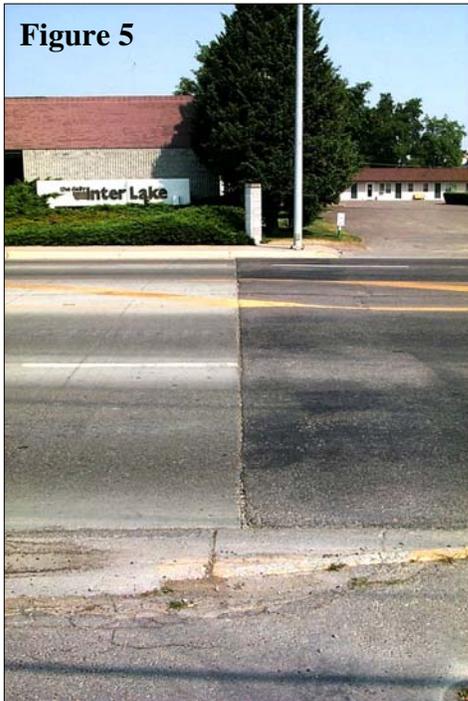
Figure 5 is showing the east-end transition area of the project. It is important to point this feature out due to the innovative way this approach was placed, please refer to the fall 2000 construction report for details. That report and additional information can be located on the MDT Research Internet website at: http://www.mdt.mt.gov/research/projects/kal_whitetopping.shtml. No evidence of distress to the east or west transitions was noticed during this evaluation.

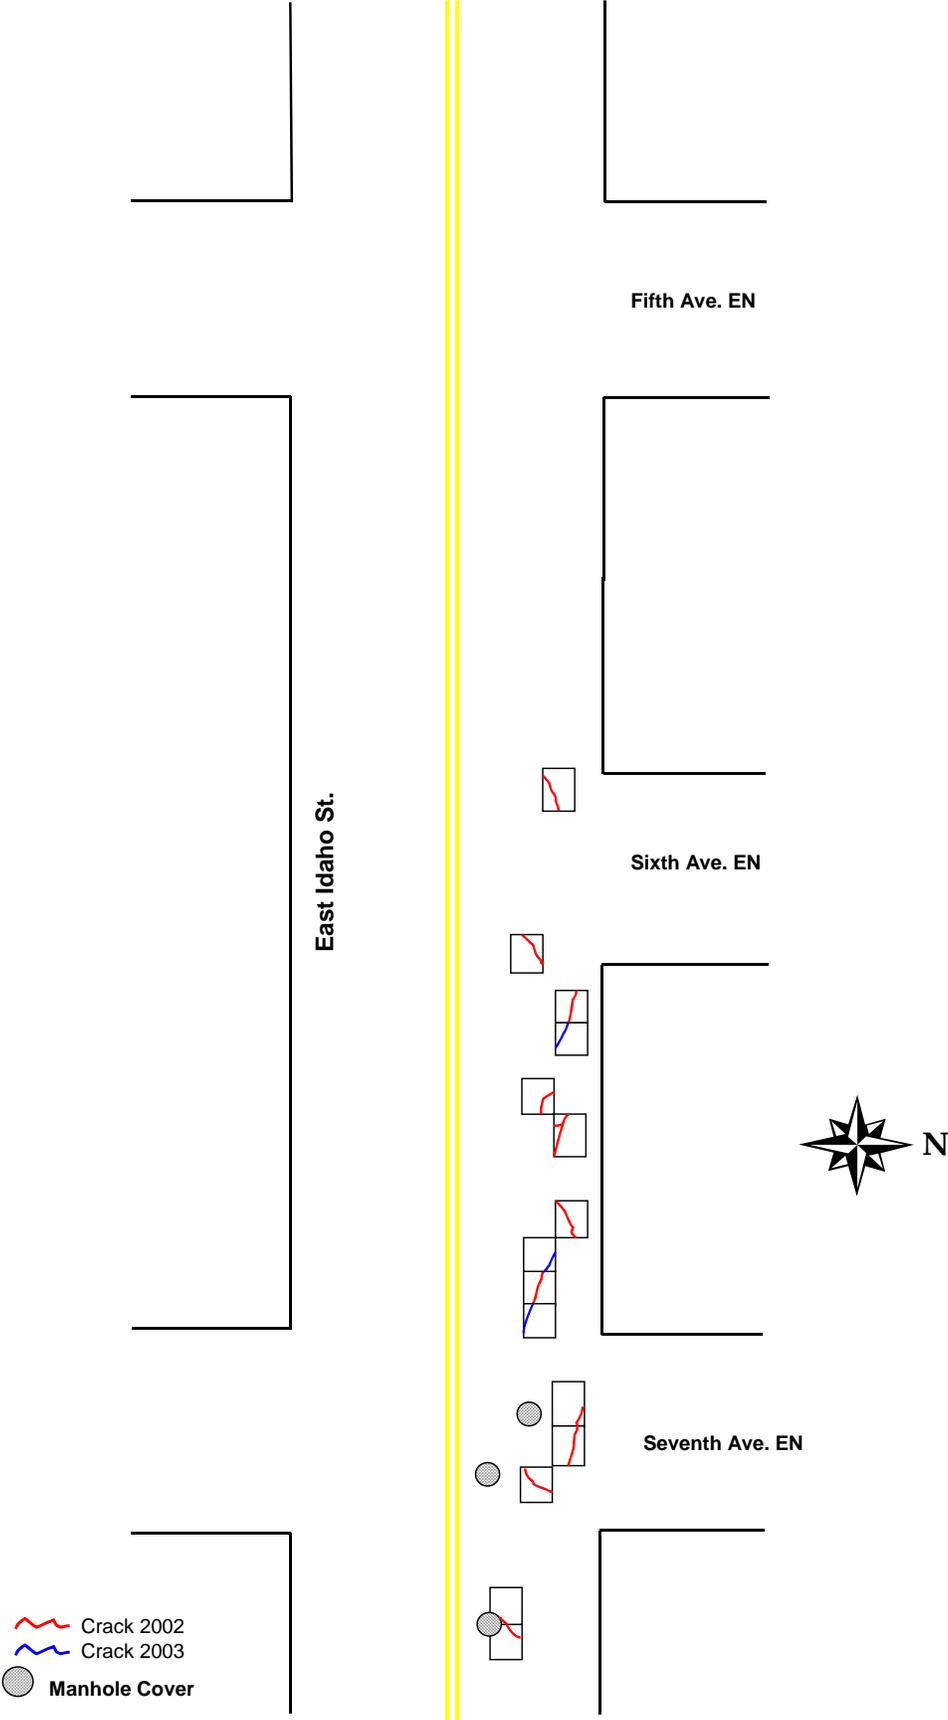
Thin-Whitetopping Overlay Composite - STPP 1-2(93) East Idaho St., Kalispell Montana
Representative Project Crack Map - Approximate Location

between the streets of 8th Ave. EN and 6th Ave. EN. The south half of the project is exhibiting no cracking at all. Refer to the crack map at the end of this report for a general representation of cracked panel locations and the relationship of how the crack is located within the panel itself. The crack map is strictly an illustration of approximate crack locations within the project. It is not to scale.

Note: Crack map only shows portion of project which contains distress information
